Improvement of Gear Durability for an 86 kW Class Agricultural Tractor Transmission by Material Selection

Abstract: This study was conducted to ensure gear durability and design optimal transmission of agricultural tractors. A field test was conducted using an 86 kW agricultural tractor for plow and rotary tillage, which are typical agricultural operations. The field test was completed after about 107 h due to transmission noise and operational problems. As a result of disassembling the transmission, it was found that the range shift A and B gears were damaged. In the case of the range shift A gear, it was judged that plastic deformation occurred due to low contact stress, and the bending stress was low, therefore gear tooth breakage occurred in the range shift B gear. In order to ensure the durability of the transmission, four materials of alloy steel for machine structural use, such as SCr420, SNCM220, SCM822, and SNC815, were selected, and the safety factor and service life according to the gear materials were compared using simulation software. As a result of simulation analysis, SCM822 satisfied the target life value and was selected as a material for change. The damaged rang

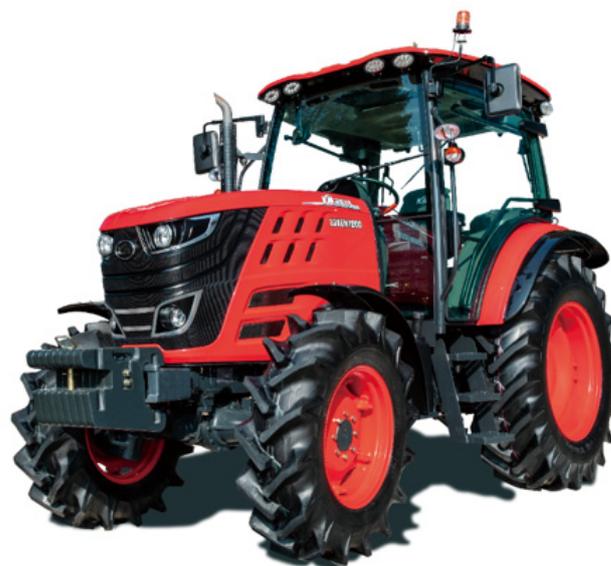
The 86 kW class agricultural tractor (Luxen1100, Kukje Machinery Co., Ltd., Ocheon, Korea) was used in the field test, as shown in Figure 1. The tractor had an empty vehicle weight of 4080 kg, and its dimensions were $4020 \times 2270 \times 2790$ mm³ (length \times width \times height). The ratios of the front and rear axles were 40.4% and 59.6%, respectively. The tractor was equipped with an 86 kW engine (4045HFK04, John Deere, Moline, IL, USA). The rated torque of the tractor was 340 Nm at the rated rotational speed of 2400 rpm, and its maximum torque was 461 Nm at 1600 rpm. The agricultural tractor used for the field test was equipped with the mechanical transmission of a power shuttle. A total of 32 travel speeds (16 forward and 16 backward) of the tractor were determined by a combination of gear stages that were selected according to agricultural operation. The specifications of the agricultural tractor used in the field test are shown in Table 1.

Figure 1. The 86 kW class agricultural tractor for the field test used in this study.

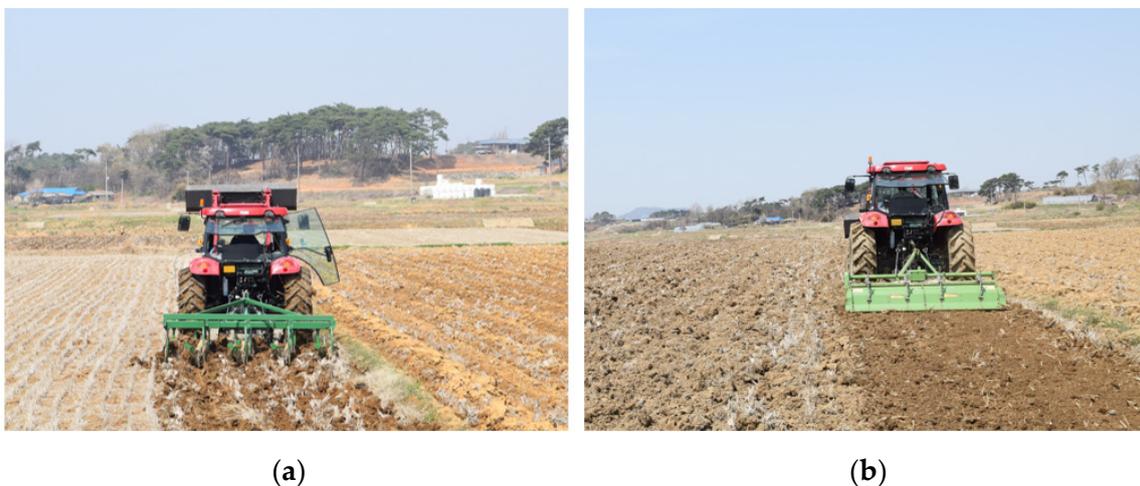
To confirm the type of gear failure, field experiments were conducted in Daeya-myeon, Gunsan-si, Jeollabuk-do Province, Korea. The size of the test site was 1980 × 100 m², and its latitudinal and longitudinal coordinates were 35°58'06" N and 126°44'14" E, respectively. The field test was conducted for typical agricultural operations, such as plow and rotary tillage, as shown in Figure 2. The plow and rotary tillage operations account for over 20% in the Korean agricultural environment [12]. The plow (WJR4PS, Woongin Machinery Co., Ltd., Gimje, Korea) and rotary (WJ255SE, Woongin Machinery Co., Ltd., Gimje, Korea) were selected as the attached implements mainly used in Korea after considering the horsepower of the tractor. The specifications of the plow and rotary are shown in Table 2. The field test was performed under full-throttle conditions of 2400 rpm and four-wheel drive mode (4WD). The plow tillage was performed in the F10 stage of 6.71 km/h, and the rotary tillage was performed in the F8 stage of 4.12 km/h. The field test conditions were selected to be the same as the conditions under which the farmers performed the agricultural operations [13]. In addition, the plow and rotary tillage were performed alternately based on the average daily agricultural operation hours in Korea of 8 h.

Figure 2. Photos of the 86 kW class agricultural tractor during the field test: (a) plow tillage; (b) rotary tillage.

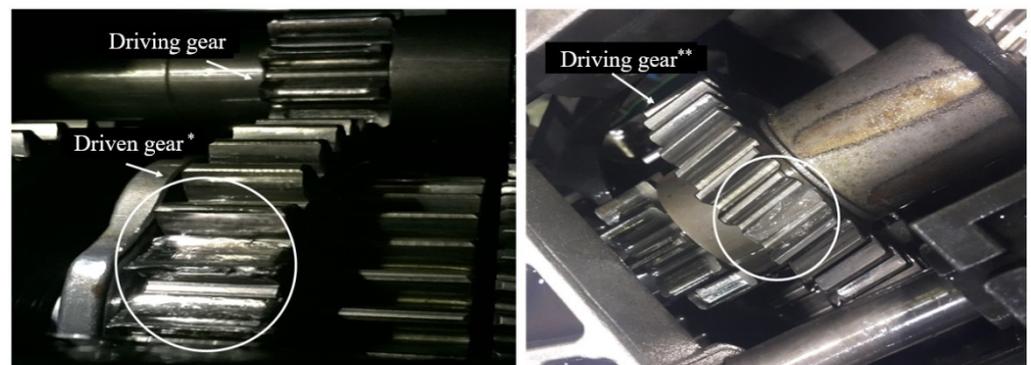
The field test was completed after 107 h due to gear noise in the transmission and defective driving operation. Figure 3 shows the results of the gear failure type after the field test, and Figure 3a details the damaged range shift A gear. The gear failure type was judged to be plastic deformation due to wear. It was confirmed that there was a gloss around the pitch line of the gear, which meant that the abrasive wear had preferentially progressed. As the wear continued to occur on the surface of the gear, it was considered that plastic deformation had occurred on the outside of the teeth of driven gear, which had relatively small tooth widths and exceeded the carburizing depth of the gear. The plastic deformation is maintained even after the load is removed, and it is caused by the rolling and sliding action of the gear under excessive load and friction. It also often occurs when high contact stress is applied to the gear tooth surface.

*Plastic deformation

**Tooth breakage

Figure 3. Results of gear failure type after field test: (a) range shift A gears; (b) range shift B gears.

Figure 3b displays the damaged range shift B driving gear; the gear failure type was judged to be gear tooth breakage, which was caused by the propagation of cracks that started inside this part as bending stress above the fatigue limit of the material was repeatedly applied to the gear root. Accordingly, it was determined that a large load was repeatedly generated during plow and rotary tillage, and the gear tooth breakage occurred in the range shift B driving gear.

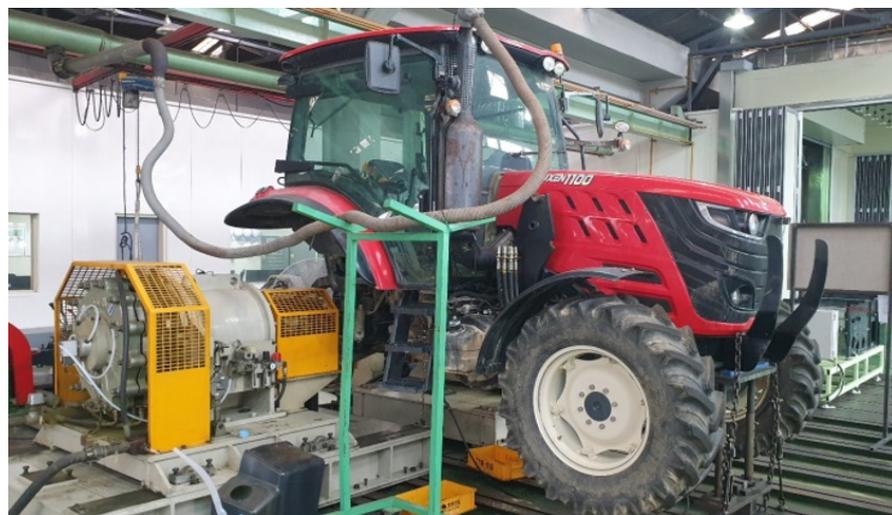
In this study, an axle dynamometer test was performed to verify the durability of the transmission to which the material selected in the simulation analysis was applied. The test bench was composed of an axle dynamometer, speedometer, air control unit, load control panel, fuel supply device, and temperature sensors for oil and coolant. Figure 6 shows the axle dynamo test of the 86 kW class agricultural tractor transmission used in this study.

Figure 6. A photo of the axle dynamometer test bench used in this study.

The axle dynamometer test was conducted under continuous equal load. The rear axles were connected to the axle dynamometer during the experiment, and load was applied to the transmission by braking with the brake in the rear axle. The load applied to the rear axles was determined based on the tractor weight, weight distribution ratio, maximum slip torque, and reduction ratio. The maximum slip torque was calculated using Equation (1) below. The weight distribution ratio of the rear axle was 0.6 according to
